**Flood Control Project Maintenance
Levee Inspections**
LMA District Cover Sheet
Spring 2020 Levee Inspection Results

Madera County FCWCA

Spring 2020 Levee Inspection Results

Waterway			Bank	Unit Miles
Unit No. 01 Ash Slough			Right	2.37
	Spring (March - May)	Summer (June - August)	(September - November) Fall	Winter (December - February)
Unit Maintenance Rating (Fall Only)				
Date of Inspection	4/14/2020 - 4/14/2020			
DWR Inspector	Corey Fujitani			
Accompanied By

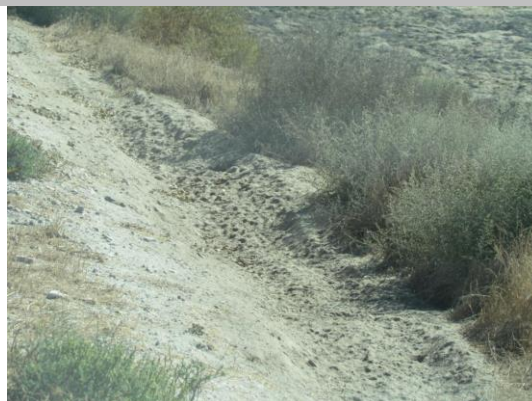
Photo 1 of 1 : SP_2020_NA0011_144_4_20200225_00002.jpg

LM Start	1.24	Rating **	M	Issue No.	4
LM End	1.25	Issue Type +	Ma	Location *	CR
Category	Earthen Levee			GPS Latitude/Longitude	
				Start	End
Item	Slope Stability			36.996582 °	36.996582 °
				-120.351482 °	-120.351258 °
DWR ID	DWR_NA0011_03_f_2016_4				
Comment Code					
S1 : Repair slope instability.					
Inspector Comment					
Repair the slope instability and damaged shoulder at this location.

Berenda Slough looking back upstream waterside at the shoulder and slope.

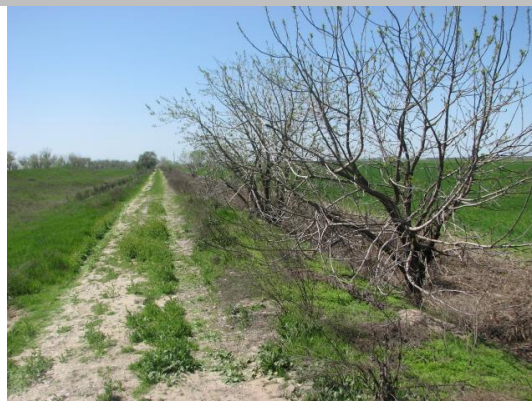
Photo 1 of 1 : SP_2020_NA0011_144_17_20200225_00015.jpg

LM Start	1.24	Rating **	U	Issue No.	17
LM End	1.29	Issue Type +	Ma	Location *	LS
Category	Earthen Levee			GPS Latitude/Longitude	
				Start	End
Item	Trim / Thin Trees			36.996632 °	36.996600 °
				-120.351463 °	-120.350539 °
DWR ID	DWR_NA0011_03_s_2012_17				
Comment Code					
T2 : Thin trees to allow visibility of the ground and room to flood fight.					
Inspector Comment					
Remove nut trees from the landside slope.

Looking at cluster of walnut trees on landward slope. (Spring 2018)

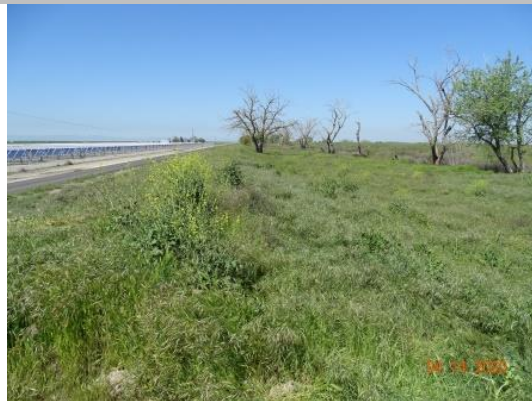
Photo 1 of 1 : SP_2020_NA0011_145_28_20200420_00031.jpg

LM Start	0.00	Rating **	U	Issue No.	28
LM End	1.50	Issue Type +	Ma	Location *	WS
Category	Earthen Levee			GPS Latitude/Longitude	
				Start	End
Item	Vegetation			36.995382 °	36.995604 °
				-120.373470 °	-120.346425 °
DWR ID	DWR_NA0011_04_s_2020_28				
Comment Code					
V1 : Control annual grass and weeds on the levee slopes and easements.					
Inspector Comment

View of the waterside slope looking downstream. (Spring 2020)

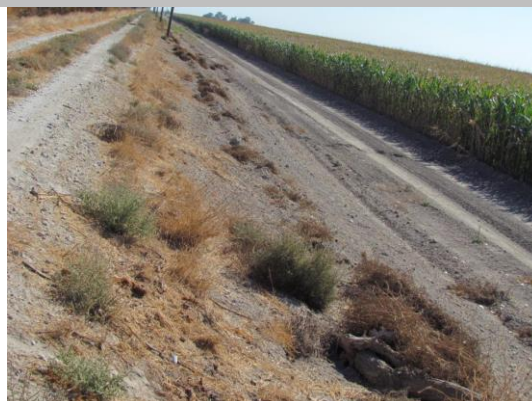
Photo 1 of 1 : SP_2020_NA0011_145_3_20200225_00001.jpg

LM Start	0.02	Rating **	U	Issue No.	3
LM End	0.97	Issue Type +	Ma	Location *	LS
Category	Earthen Levee			GPS Latitude/Longitude	
				Start	End
Item	Slope Stability			36.995506 °	36.995550 °
				-120.373233 °	-120.355935 °
DWR ID	DWR_NA0011_04_f_2016_3				
Comment Code					
S1 : Repair slope instability.					
Inspector Comment					
The slope in this area has been damaged by farm equipment.

Berenda Slough Unit 4 Looking upstream from levee mile 0.14-0.97.

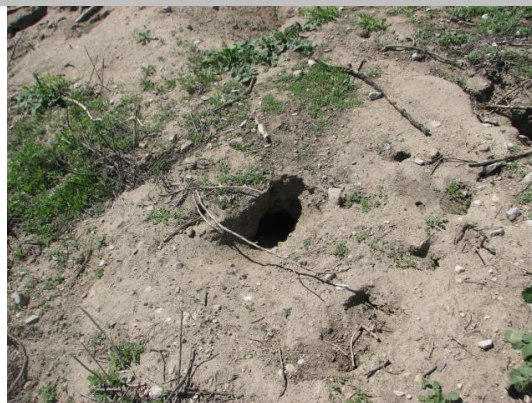
Photo 1 of 1 : SP_2020_NA0011_145_19_20200225_00017.jpg

LM Start	0.12	Rating **	U	Issue No.	19
LM End	0.94	Issue Type +	Ma	Location *	LS
Category	Earthen Levee			GPS Latitude/Longitude	
				Start	End
Item	Animal Control			36.995547 °	36.995586 °
				-120.371410 °	-120.356589 °
DWR ID	DWR_NA0011_04_s_2018_19				
Comment Code					
A3 : No rodents visible, but rodent burrows visible; need to backfill and compact or grout burrows.					
Inspector Comment

Looking at large rodent hole on landward slope. (Spring 2018)

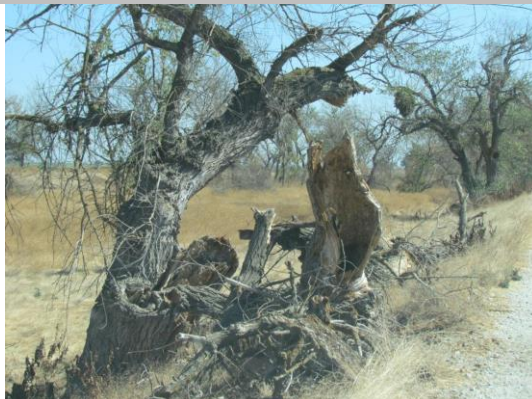
Photo 1 of 1 : SP_2020_NA0011_145_15_20200225_00014.jpg

LM Start	0.14	Rating **	U	Issue No.	15
LM End	0.14	Issue Type +	Ma	Location *	WS
Category	Earthen Levee			GPS Latitude/Longitude	
				Start	End
Item	Encroachments			36.995528 °	36.995528 °
				-120.370922 °	-120.370922 °
DWR ID	DWR_NA0011_04_f_2015_15				
Comment Code					
TR : Tree or limb					
Inspector Comment					
There are many dead trees in the area. Remove the dead trees from the levee section. Many more are subject to fall and possibly block access to the levee crown.

Berenda Slough looking upstream from the levee mile 0.14.

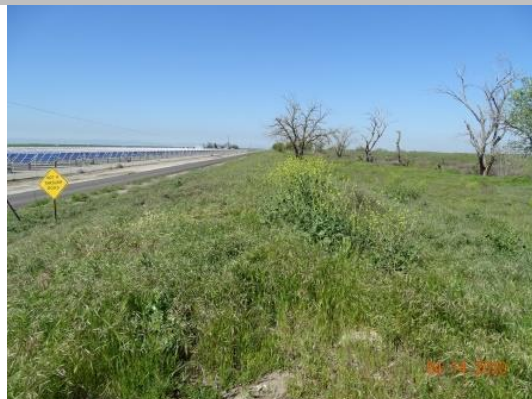
Photo 1 of 1 : SP_2020_NA0011_145_34_20200420_00033.jpg

LM Start	0.93	Rating **	U	Issue No.	34
LM End	1.50	Issue Type +	Ma	Location *	CR
Category	Earthen Levee			GPS Latitude/Longitude	
				Start	End
Item	Vegetation			36.995582 °	36.995604 °
				-120.356689 °	-120.346425 °
DWR ID	DWR_NA0011_04_s_2020_34				
Comment Code					
V9 : Keep the crown roadway free of vegetation.					
Inspector Comment

Looking upstream along the levee crown. (Spring 2020)

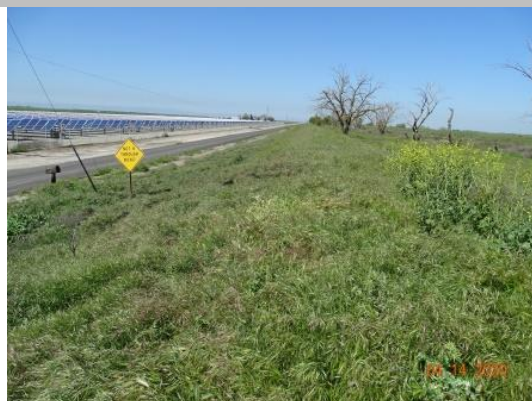
Photo 1 of 1 : SP_2020_NA0011_145_4_20200420_00034.jpg

LM Start	0.93	Rating **	U	Issue No.	4
LM End	1.50	Issue Type +	Ma	Location *	LS
Category	Earthen Levee			GPS Latitude/Longitude	
				Start	End
Item	Vegetation			36.995583 °	36.995604 °
				-120.356688 °	-120.346425 °
DWR ID	DWR_NA0011_04_s_2020_4				
Comment Code					
V1 : Control annual grass and weeds on the levee slopes and easements.					
Inspector Comment

Looking upstream at LM 1.50 along the landside slope. (Spring 2020)

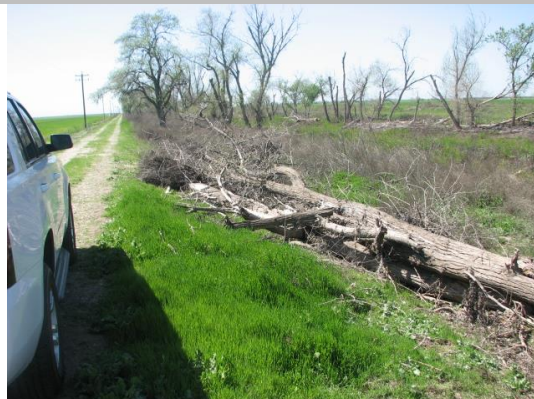
Photo 1 of 1 : SP_2020_NA0011_145_14_20200225_00013.jpg

LM Start	0.94	Rating **	M	Issue No.	14
LM End	0.94	Issue Type +	Ma	Location *	WS
Category	Earthen Levee			GPS Latitude/Longitude	
				Start	End
Item	Encroachments			36.995573 °	36.995573 °
				-120.356601 °	-120.356601 °
DWR ID	DWR_NA0011_04_f _ 2017_14				
Comment Code					
TR : Tree or limb					
Inspector Comment					
Remove the downed tree from the waterside slope.

Looking upstream at fallen tree on waterward slope. (Spring 2018)

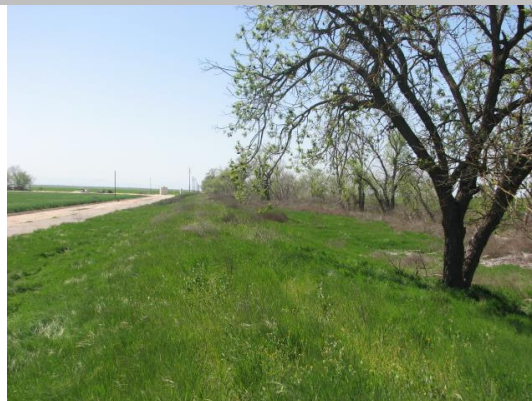
Photo 1 of 1 : SP_2020_NA0011_145_10_20200225_00007.jpg

LM Start	1.19	Rating **	M	Issue No.	10
LM End	1.19	Issue Type +	Ma	Location *	WS
Category	Earthen Levee			GPS Latitude/Longitude	
				Start	End
Item	Trim / Thin Trees			36.995566 °	36.995566 °
				-120.352038 °	-120.352038 °
DWR ID	DWR_NA0011_04_f_2017_10				
Comment Code					
T4 : Trim trees over roadway to at least 12 feet above ground level.					
Inspector Comment

Looking upstream at tree on waterward slope. (Spring 2018)

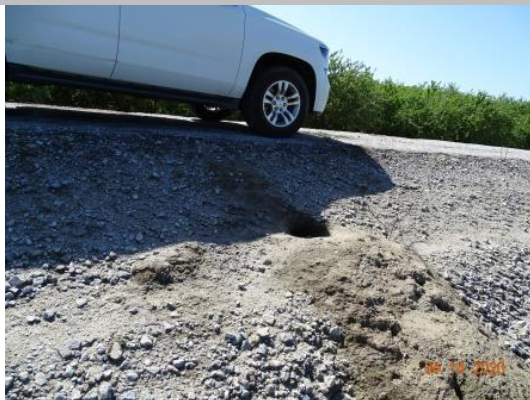
Photo 1 of 1 : SP_2020_NA0011_145_30_20200420_00036.jpg

LM Start	1.50	Rating **	U	Issue No.	30
LM End	2.28	Issue Type +	Ma	Location *	WS
Category	Earthen Levee			GPS Latitude/Longitude	
				Start	End
Item	Animal Control			36.995590 °	37.003740 °
				-120.346406 °	-120.336877 °
DWR ID	DWR_NA0011_04_f_2014_30				
Comment Code					
A1 : Exterminate rodents and backfill and compact or grout burrows.					
Inspector Comment					
Bait stations are needed in the rodent infested area on the waterside slope and toe.

Several large rodent holes on waterside slope. (Spring 2020)

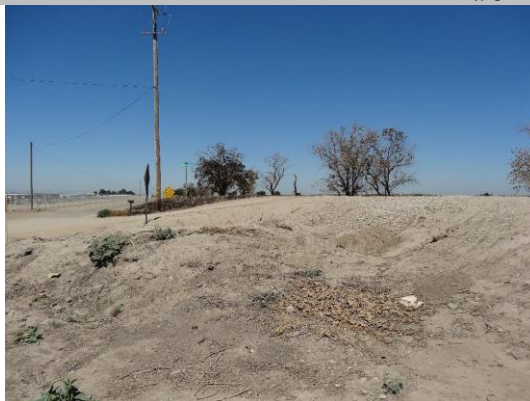
Photo 1 of 3 : UCIP_SP_2020_53154_75760.jpg

LM Start	1.50	Rating **	U	Issue No.	60	
LM End	1.50	Issue Type +	En	Location *		
Category	Supplemental			GPS Latitude/Longitude		
				Start	End	
Item	DWR UCIP Field Study			36.995597 °	36.995597 °	
				-120.346418 °	-120.346418 °	
DWR ID	25469

Comment Code						
Inspector Comment						
DS_ID:25469 FS_ID:53154 EP_NO: N/A Repair Type: Urgent Crossing Status: Found UCIP Comments: 10/31/2018 Same as last inspection with the exception of the size of the sink hole. Sink hole on LS slope has increased. Levee at this crossing is composed of highly erodible material. Need to coordinate with the pipe owner to determine repair status. Crossing remains Urgent due to the large sink hole present on the LS. (O. Magana - DWR UCIP) 07/14/2016 New entry added--pipe failure. Sink hole present on LS slope. Concrete headwall collapse visible on LS slope. Pipe buried on both WS and LS. (DWR UCIP - omagana) FIELD_STRUCT_DESC: 24-inch (estimate measurement based on flap gate frame) gravity drainage pipe of an unknown material through the levee, approximately 5 feet below the crown. Concrete headwall on the landside (LS). Corrugated metal pipe (CMP) at the LS toe. Sluice gate on the waterside (WS). This crossing was field discovered. FS Date: 10/31/2018 10:19:00 AM

View of LS slope.

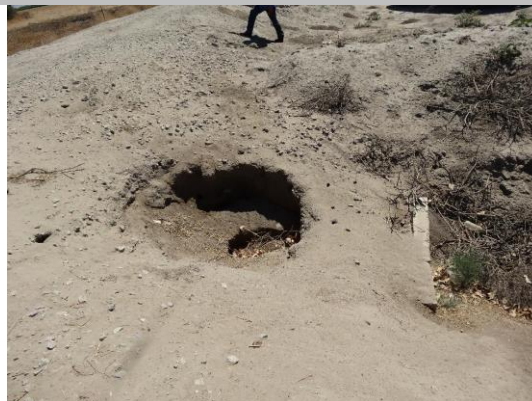
Photo 3 of 3 : UCIP_SP_2020_53154_75762.jpg

LM Start	1.50	Rating **	U	Issue No.	60 (cont)
LM End	1.50	Issue Type +	En	Location *

Sink hole located immediately above concrete headwall visible on LS.

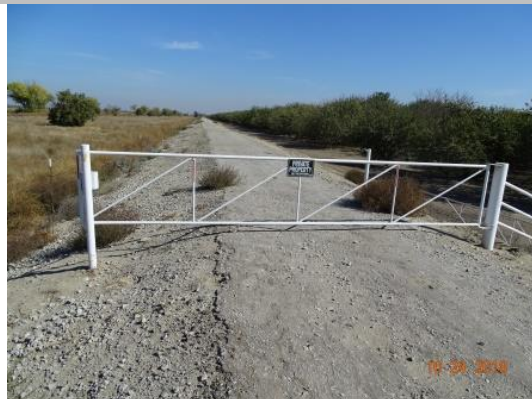
Photo 1 of 1 : SP_2020_NA0011_145_17_20200225_00016.jpg

LM Start	1.60	Rating **	M	Issue No.	17
LM End	1.60	Issue Type +	En	Location *	CR
Category	Earthen Levee			GPS Latitude/Longitude	
				Start	End
Item	Encroachments			36.996212 °	36.996212 °
				-120.344756 °	-120.344756 °
DWR ID	DWR_NA0011_04_f_2018_17				
Comment Code					
FE : Fence					
Inspector Comment					
Gate with combo lock. No permit associated with gate.

Gate blocking access to levee. (Fall 2018)

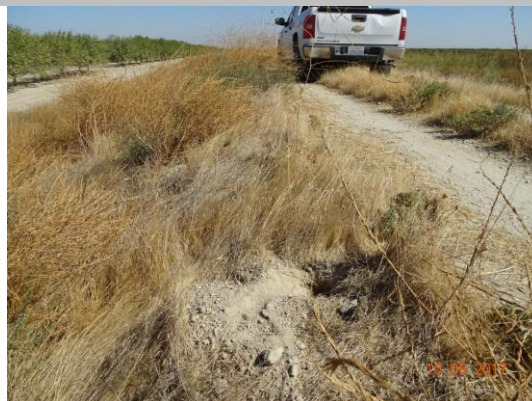
Photo 1 of 1 : SP_2020_NA0011_146_14_20200225_00010.jpg

LM Start	0.00	Rating **	M	Issue No.	14
LM End	4.05	Issue Type +	Ma	Location *	LS
Category	Earthen Levee			GPS Latitude/Longitude	
				Start	End
Item	Animal Control			36.978520 °	36.968168 °
				-120.368567 °	-120.301035 °
DWR ID	DWR_NA0011_05_f_2016_14				
Comment Code					
A1 : Exterminate rodents and backfill and compact or grout burrows.					
Inspector Comment					
Exterminate the rodents along the landside slope and toe throughout the area to levee mile 4.05. Bait stations are needed in infested areas.

Rodent activity on landside slope.

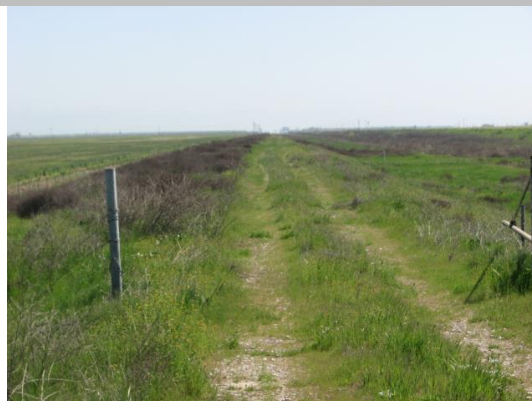
Photo 1 of 1 : SP_2020_NA0011_146_13_20200225_00009.jpg

LM Start	0.00	Rating **	M	Issue No.	13
LM End	4.05	Issue Type +	Ma	Location *	CR
Category	Earthen Levee			GPS Latitude/Longitude	
				Start	End
Item	Crown Surface / Depressions / Rutting			36.978548 °	36.968165 °
				-120.368454 °	-120.301151 °
DWR ID	DWR_NA0011_05_s_2012_13				
Comment Code					
C1 : Add appropriate material and re-grade the levee to bring the crown above the design elevation.					
Inspector Comment					
Regrade the crown for proper drainage. And add appropriate gravel or road base.

Looking downstream at levee crown from 0.00. (Spring 2018)

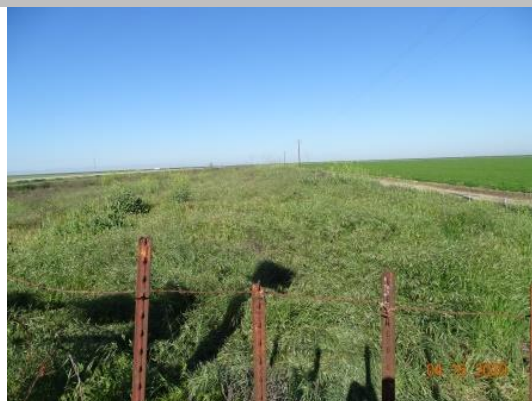
Photo 1 of 1 : SP_2020_NA0011_146_23_20200504_00051.jpg

LM Start	0.01	Rating **	U	Issue No.	23
LM End	4.05	Issue Type +	Ma	Location *	WS
Category	Earthen Levee			GPS Latitude/Longitude	
				Start	End
Item	Vegetation			36.978540 °	36.968172 °
				-120.368320 °	-120.300987 °
DWR ID	DWR_NA0011_05_s_2020_23				
Comment Code					
V1 : Control annual grass and weeds on the levee slopes and easements.					
Inspector Comment

Looking downstream along the waterside slope at LM 4.05. (Spring 2020)

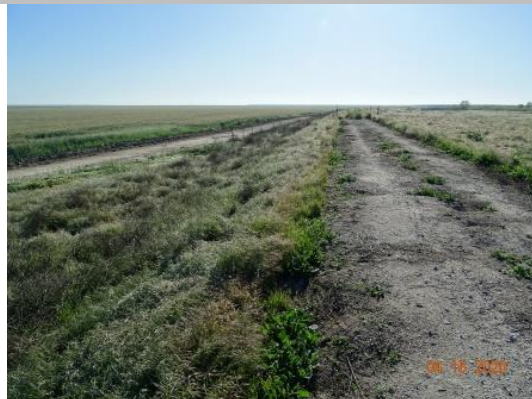
Photo 1 of 1 : SP_2020_NA0011_146_21_20200504_00049.jpg

LM Start	0.01	Rating **	U	Issue No.	21
LM End	4.05	Issue Type +	Ma	Location *	LS
Category	Earthen Levee			GPS Latitude/Longitude	
				Start	End
Item	Vegetation			36.978540 °	36.968171 °
				-120.368318 °	-120.300987 °
DWR ID	DWR_NA0011_05_s_2020_21				
Comment Code					
V1 : Control annual grass and weeds on the levee slopes and easements.					
Inspector Comment

View of the landside slope at LM 0.00. (Spring 2020)

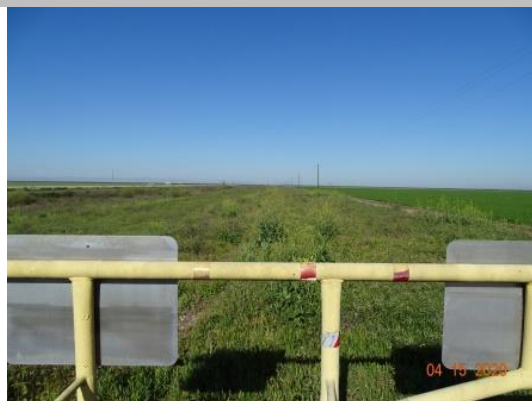
Photo 1 of 1 : SP_2020_NA0011_146_31_20200504_00052.jpg

LM Start	0.04	Rating **	U	Issue No.	31
LM End	4.05	Issue Type +	Ma	Location *	CR
Category	Earthen Levee			GPS Latitude/Longitude	
				Start	End
Item	Vegetation			36.978507 °	36.968172 °
				-120.367803 °	-120.300987 °
DWR ID	DWR_NA0011_05_s_2020_31				
Comment Code					
V9 : Keep the crown roadway free of vegetation.					
Inspector Comment

Looking downstream at the levee crown at LM 4.05. (Spring 2020)

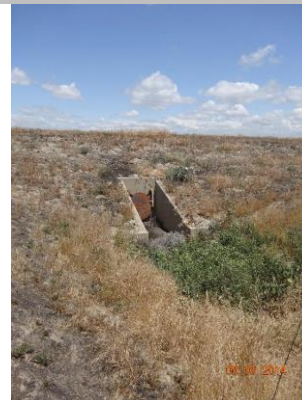
Photo 2 of 3 : UCIP_SP_2020_52833_64566.jpg

View of flap gate and concrete headwall located on waterward side.

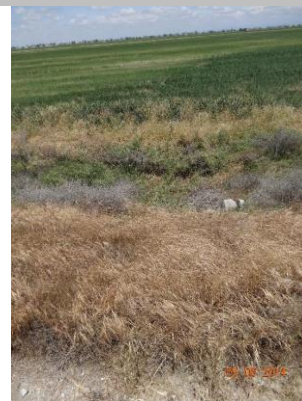
Photo 3 of 3 : UCIP_SP_2020_52833_64565.jpg

LM Start	0.18	Rating **	M	Issue No.	52 (cont)
LM End	0.18	Issue Type +	En	Location *	
Category	Supplemental		GPS Latitude/Longitude		
			Start	End	
Item	DWR UCIP Field Study		36.978036 °	36.978036 °	
			-120.365246 °	-120.365246 °	
DWR ID	21520

View of landward side.

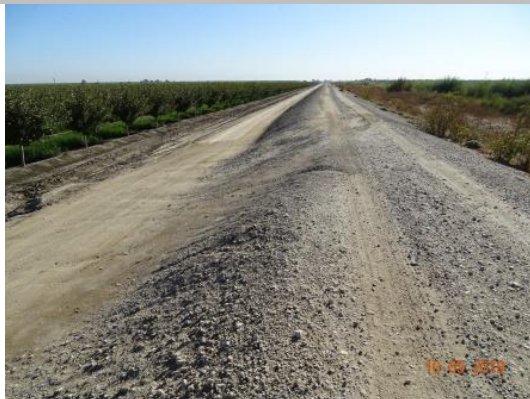
Photo 1 of 1 : SP_2020_NA0011_146_18_20200225_00013.jpg

LM Start	5.56	Rating **	M	Issue No.	18
LM End	5.56	Issue Type +	Ma	Location *	LS
Category	Earthen Levee			GPS Latitude/Longitude	
				Start	End
Item	Slope Stability			36.968210 °	36.968210 °
				-120.273729 °	-120.273729 °
DWR ID	DWR_NA0011_05_f _ 2017_18				
Comment Code					
S3 : Repair the levee slope damaged by vehicle traffic and prevent access where possible.					
Inspector Comment					
Repair damage from vehicle traffic on slope and shoulder.

Damage to landside shoulder and slope looking upstream. (Fall 2019)

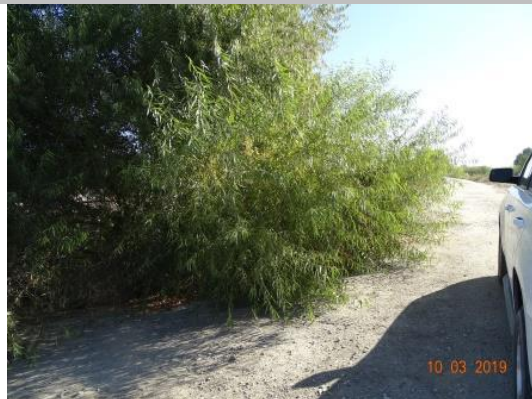
Photo 1 of 1 : SP_2020_NA0011_146_29_20200225_00021.jpg

LM Start	6.57	Rating **	U	Issue No.	29
LM End	6.57	Issue Type +	Ma	Location *	LS
Category	Earthen Levee			GPS Latitude/Longitude	
				Start	End
Item	Trim / Thin Trees			36.968477 °	36.968477 °
				-120.255557 °	-120.255557 °
DWR ID	DWR_NA0011_05_f_2019_29				
Comment Code					
T2 : Thin trees to allow visibility of the ground and room to flood fight.					
Inspector Comment					
Tree should be trimmed above the levee crown and 5 feet above the slope.

View of tree growing on landside slope looking upstream. (Fall 2019)

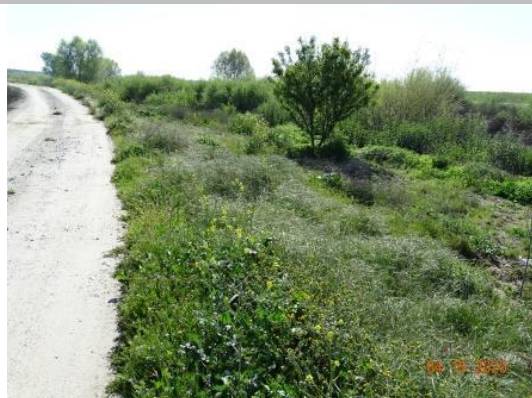
Photo 1 of 1 : SP_2020_NA0011_146_39_20200504_00058.jpg

LM Start	6.58	Rating **	U	Issue No.	39
LM End	7.53	Issue Type +	Ma	Location *	WS
Category	Earthen Levee			GPS Latitude/Longitude	
				Start	End
Item	Vegetation			36.968503 °	36.969536 °
				-120.255373 °	-120.238480 °
DWR ID	DWR_NA0011_05_s_2020_39				
Comment Code					
V1 : Control annual grass and weeds on the levee slopes and easements.					
Inspector Comment

View of vegetation along the waterside slope looking upstream. (Spring 2020)

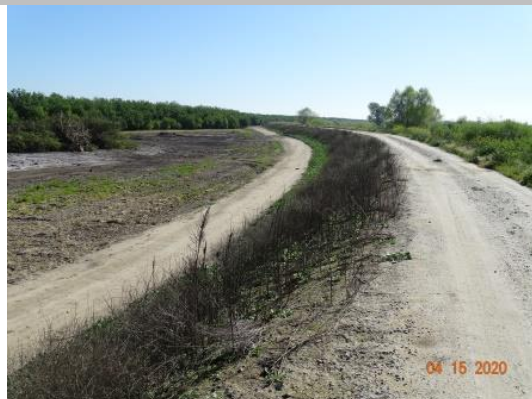
Photo 1 of 1 : SP_2020_NA0011_146_44_20200504_00059.jpg

LM Start	6.59	Rating **	M	Issue No.	44
LM End	7.53	Issue Type +	Ma	Location *	LS
Category	Earthen Levee			GPS Latitude/Longitude	
				Start	End
Item	Vegetation			36.968500 °	36.969536 °
				-120.255240 °	-120.238480 °
DWR ID	DWR_NA0011_05_s_2020_44				
Comment Code					
V1 : Control annual grass and weeds on the levee slopes and easements.					
Inspector Comment

Looking upstream along the landside slope. (Spring 2020)

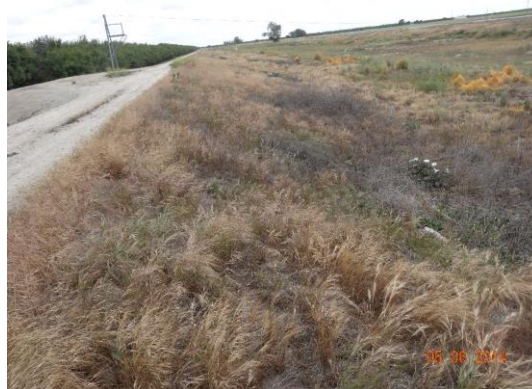
Photo 1 of 3 : UCIP_SP_2020_52859_69715.jpg

Comment Code						
Inspector Comment						
DS_ID:21527						
FS_ID:52859						
EP_NO: N/A						
Repair Type: Non-Urgent						
Crossing Status: Found						
UCIP Comments: 05/06/2014 Need to contact owner. Dense vegetation limits the inspector's visibility to identify signs of pipe failure (leaks) along the waterward slope. Recommend removing vegetation along pipe alignment to conduct proper inspection of structure and appurtenances. Slide gate buried on landward side. Recommend clearing sediment deposit on landward side. (DWR UCIP - O. Magana)						
FIELD_STRUCT_DESC: 30-inch corrugated metal gravity drainage pipe through the levee, 9.4 feet below the crown. Headwall and wing wall on each end. Flap gate on the waterside (WS) end. [Additional Reference(s): DWR Levee Log, 2005].						
FS Date: 5/6/2014

View of waterward side.

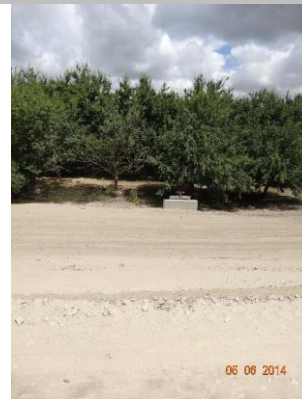
Photo 3 of 3 : UCIP_SP_2020_52859_69713.jpg

LM Start	6.87	Rating **	M	Issue No.	53 (cont)
LM End	6.87	Issue Type +	En	Location *	
Category	Supplemental			GPS Latitude/Longitude	
				Start	End
Item	DWR UCIP Field Study			36.969520 °	36.969520 °
				-120.250311 °	-120.250311 °
DWR ID	21527

View of landward side.

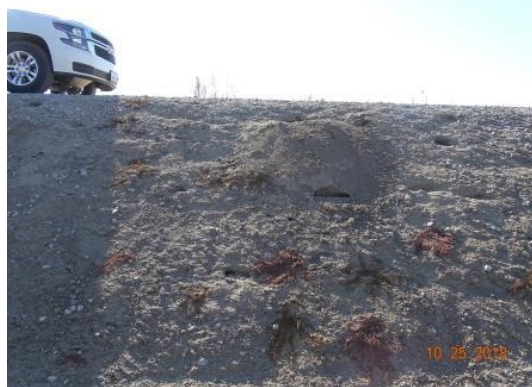
Photo 1 of 1 : SP_2020_NA0011_146_12_20200225_00008.jpg

LM Start	7.99	Rating **	U	Issue No.	12
LM End	8.01	Issue Type +	Ma	Location *	LS
Category	Earthen Levee			GPS Latitude/Longitude	
				Start	End
Item	Animal Control			36.972121 °	36.972186 °
				-120.230994 °	-120.230772 °
DWR ID	DWR_NA0011_05_f_2018_12				
Comment Code					
A3 : No rodents visible, but rodent burrows visible; need to backfill and compact or grout burrows.					
Inspector Comment					
Large rodent burrow observed in this section.

Rodent activity on landside slope. (Fall 2018)

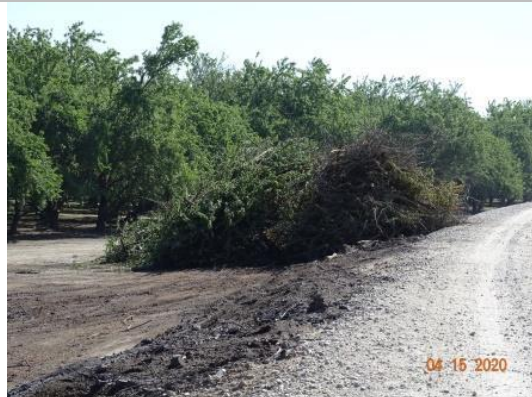
Photo 1 of 1 : SP_2020_NA0011_146_35_20200504_00060.jpg

LM Start	8.38	Rating **	U	Issue No.	35
LM End	8.41	Issue Type +	En	Location *	LS
Category	Earthen Levee			GPS Latitude/Longitude	
				Start	End
Item	Encroachments			36.972936 °	36.972947 °
				-120.224106 °	-120.223607 °
DWR ID	DWR_NA0011_05_f_2015_35				
Comment Code					
PR : Prunings					
Inspector Comment					
Move burnpile away from levee as it provides cover for burrowing rodents.

Burn pile left on the landside slope and toe. (Spring 2020)

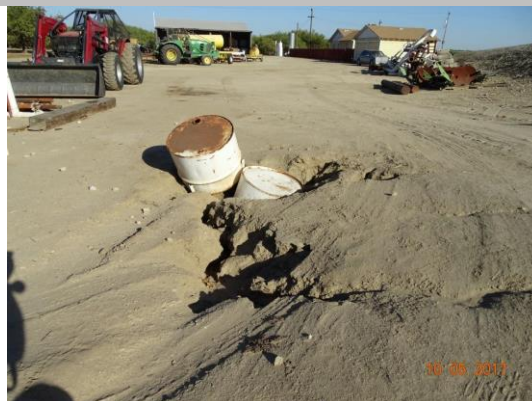
Photo 1 of 1 : SP_2020_NA0011_146_25_20200225_00017.jpg

LM Start	8.53	Rating **	M	Issue No.	25
LM End	8.53	Issue Type +	En	Location *	LS
Category	Earthen Levee			GPS Latitude/Longitude	
				Start	End
Item	Encroachments			36.972643 °	36.972643 °
				-120.221488 °	-120.221488 °
DWR ID	DWR_NA0011_05_f _ 2017_25				
Comment Code					
PI : Pipe					
Inspector Comment					
Possible sinkhole 10 feet from landside levee toe. 6 ft long by 1-2 ft wide by 5.5 ft deep. 55gal drum halves were placed in hole for safety. Met with Rick Cosyns (MID 559-232-0227) on site. Speculated that it was likely an underground pipe with collapsed backfill.

Possible sinkhole 10 feet from landside levee toe. 6 ft long by 1-2 ft wide by 5.5 ft deep. White 55gal drum halves were placed in hole for safety. (Fall 2017)

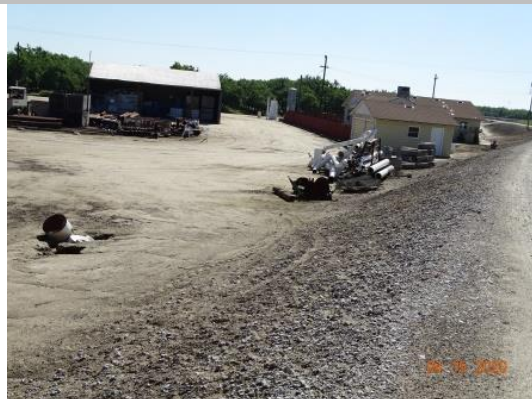
Photo 1 of 1 : SP_2020_NA0011_146_26_20200504_00062.jpg

LM Start	8.53	Rating **	M	Issue No.	26
LM End	8.53	Issue Type +	En	Location *	LS
Category	Earthen Levee			GPS Latitude/Longitude	
				Start	End
Item	Encroachments			36.972616 °	36.972606 °
				-120.221415 °	-120.221389 °
DWR ID	DWR_NA0011_05_f_2017_26				
Comment Code					
EQ : Equipment					
Inspector Comment					
Concrete pipes at landward toe.

Pipes and equipment stored along the landside toe. (Spring 2020)

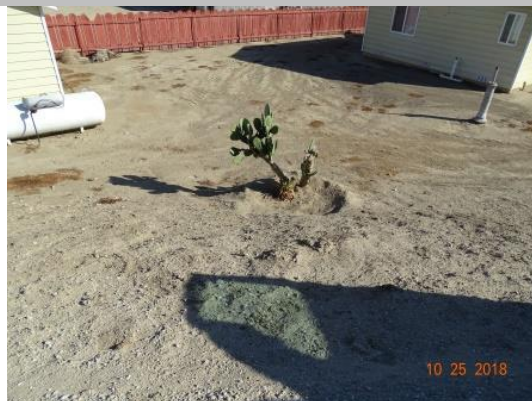
Photo 1 of 1 : SP_2020_NA0011_146_11_20200225_00007.jpg

LM Start	8.56	Rating **	M	Issue No.	11
LM End	8.56	Issue Type +	En	Location *	LS
Category	Earthen Levee			GPS Latitude/Longitude	
				Start	End
Item	Vegetation			36.972384 °	36.972384 °
				-120.220907 °	-120.220907 °
DWR ID	DWR_NA0011_05_f_2018_11				
Comment Code					
V6 : Landscaping					
Inspector Comment					
Cactus planted on landside toe.

Cactus on landside toe. (Fall 2018)

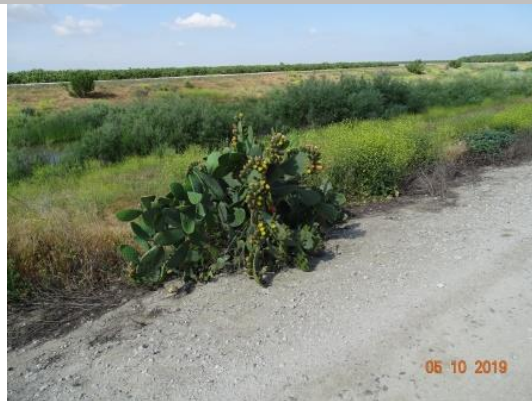
Photo 1 of 1 : SP_2020_NA0011_146_10_20200225_00005.jpg

LM Start	8.57	Rating **	U	Issue No.	10
LM End	8.57	Issue Type +	Ma	Location *	WS
Category	Earthen Levee			GPS Latitude/Longitude	
				Start	End
Item	Vegetation			36.972355 °	36.972355 °
				-120.220878 °	-120.220878 °
DWR ID	DWR_NA0011_05_f _ 2018_10				
Comment Code					
V2 : Remove the wild growth other than native grasses from the levee slopes.					
Inspector Comment					
Cactus growing on waterside slope.

Cactus growing on waterside shoulder. (Spring 2019)

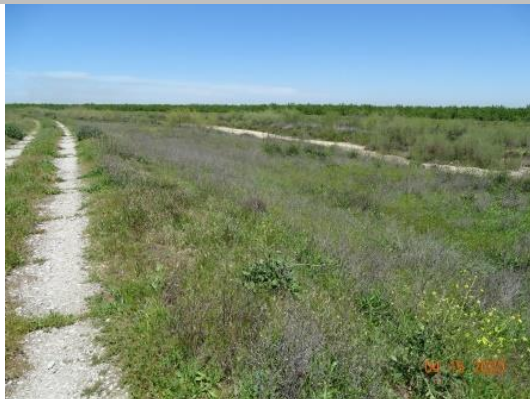
Photo 1 of 1 : SP_2020_NA0011_147_73_20200504_00054.jpg

LM Start	0.00	Rating **	U	Issue No.	73
LM End	0.93	Issue Type +	Ma	Location *	WS
Category	Earthen Levee			GPS Latitude/Longitude	
				Start	End
Item	Vegetation			36.976941 °	36.969700 °
				-120.367494 °	-120.354557 °
DWR ID	DWR_NA0011_06_s_2020_73				
Comment Code					
V1 : Control annual grass and weeds on the levee slopes and easements.					
Inspector Comment

View of the waterside slope looking downstream. (Spring 2020)

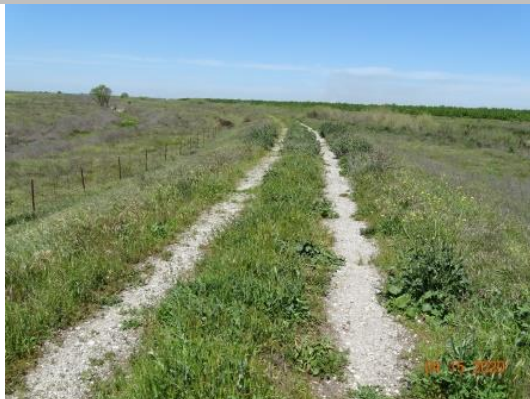
Photo 1 of 1 : SP_2020_NA0011_147_74_20200504_00055.jpg

LM Start	0.00	Rating **	U	Issue No.	74
LM End	0.93	Issue Type +	Ma	Location *	CR
Category	Earthen Levee			GPS Latitude/Longitude	
				Start	End
Item	Vegetation			36.976941 °	36.969700 °
				-120.367494 °	-120.354557 °
DWR ID	DWR_NA0011_06_s_2020_74				
Comment Code					
V9 : Keep the crown roadway free of vegetation.					
Inspector Comment

Looking downstream along the levee crown. (Spring 2020)

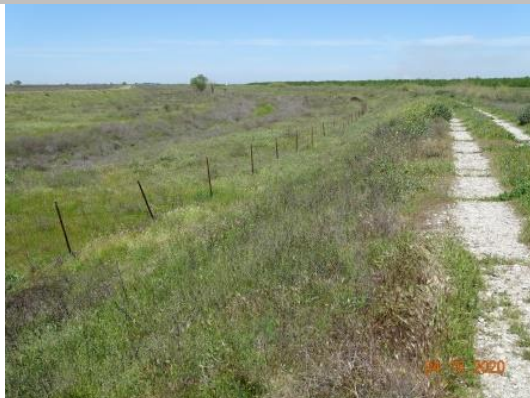
Photo 1 of 1 : SP_2020_NA0011_147_72_20200519_00067.jpg

LM Start	0.00	Rating **	U	Issue No.	72
LM End	0.93	Issue Type +	Ma	Location *	LS
Category	Earthen Levee			GPS Latitude/Longitude	
				Start	End
Item	Vegetation			36.976941 °	36.969700 °
				-120.367494 °	-120.354556 °
DWR ID	DWR_NA0011_06_s_2020_72				
Comment Code					
V1 : Control annual grass and weeds on the levee slopes and easements.					
Inspector Comment

View of vegetation along the landside slope looking downstream. (Spring 2020)

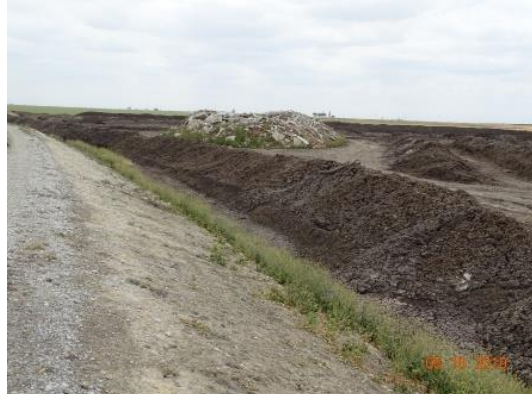
Photo 1 of 1 : SP_2020_NA0011_147_85_20200225_00035.jpg

LM Start	0.99	Rating **	U	Issue No.	85
LM End	1.07	Issue Type +	En	Location *	LS
Category	Earthen Levee			GPS Latitude/Longitude	
				Start	End
Item	Encroachments			36.968930 °	36.967985 °
				-120.354292 °	-120.353510 °
DWR ID	DWR_NA0011_06_s_2019_85				
Comment Code					
MA : Material					
Inspector Comment					
Soil material piled up on levee toe should be pushed back 10 feet from slope.

View of soil encroachment piled along levee toe. (Spring 2019)

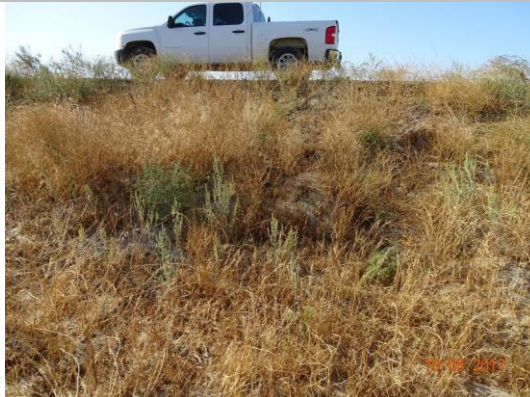
Photo 1 of 1 : SP_2020_NA0011_147_17_20200225_00006.jpg

LM Start	1.02	Rating **	U	Issue No.	17
LM End	1.15	Issue Type +	Ma	Location *	WS
Category	Earthen Levee			GPS Latitude/Longitude	
				Start	End
Item	Slope Stability			36.968520 °	36.967334 °
				-120.354012 °	-120.352154 °
DWR ID	DWR_NA0011_06_f_2017_17				
Comment Code					
S1 : Repair slope instability.					
Inspector Comment					
Observed slump possibly exacerbated by rodent activity. 20' long x 8' high x 18" deep into levee slope.

Observed slump possibly exacerbated by rodent activity. 20' long x 8' high x 18" deep into levee slope.

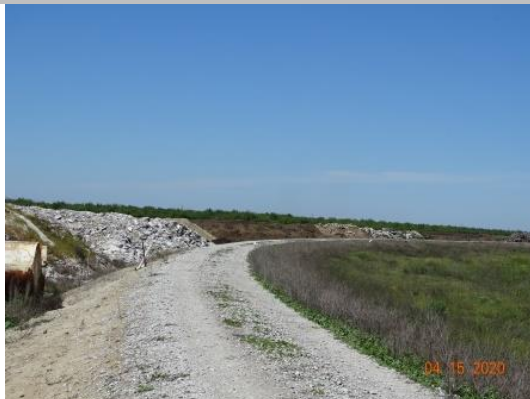
Photo 1 of 1 : SP_2020_NA0011_147_1_20200504_00056.jpg

LM Start	1.08	Rating **	U	Issue No.	1
LM End	1.14	Issue Type +	En	Location *	LS
Category	Earthen Levee			GPS Latitude/Longitude	
				Start	End
Item	Encroachments			36.967781 °	36.967395 °
				-120.353321 °	-120.352362 °
DWR ID	DWR_NA0011_06_s_2012_1				
Comment Code					
DE : Debris					
Inspector Comment					
Large piles of broken up recycled sheet rock placed within 10-foot of the levee easement.

Material piled along the levee toe and easement. (Spring 2020)

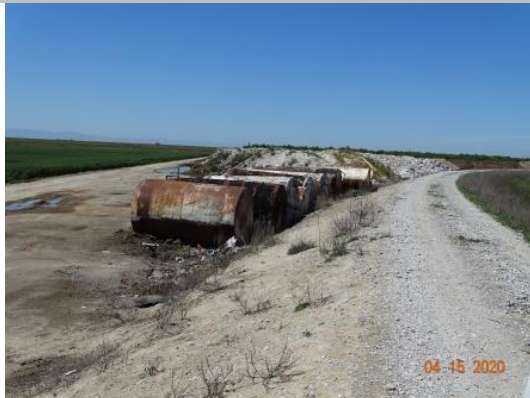
Photo 1 of 1 : SP_2020_NA0011_147_39_20200504_00057.jpg

LM Start	1.14	Rating **	U	Issue No.	39
LM End	1.17	Issue Type +	En	Location *	LS
Category	Earthen Levee			GPS Latitude/Longitude	
				Start	End
Item	Encroachments			36.967387 °	36.967270 °
				-120.352340 °	-120.351902 °
DWR ID	DWR_NA0011_06_s_2014_39				
Comment Code					
TA : Tank					
Inspector Comment					
Metal storage tanks are within the easement of the landward toe. Move them away from the easement.

Tanks stored on the landside levee toe. (Spring 2020)

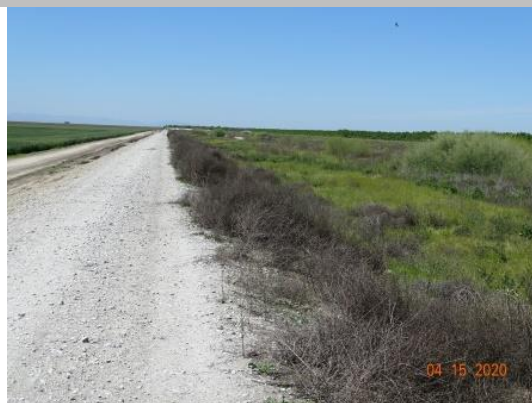
Photo 1 of 1 : SP_2020_NA0011_147_70_20200504_00058.jpg

LM Start	1.44	Rating **	U	Issue No.	70
LM End	1.75	Issue Type +	Ma	Location *	WS
Category	Earthen Levee			GPS Latitude/Longitude	
				Start	End
Item	Vegetation			36.967173 °	36.967196 °
				-120.347058 °	-120.341466 °
DWR ID	DWR_NA0011_06_s_2020_70				
Comment Code					
V1 : Control annual grass and weeds on the levee slopes and easements.					
Inspector Comment

View of vegetation along the waterside slope. (Spring 2020)

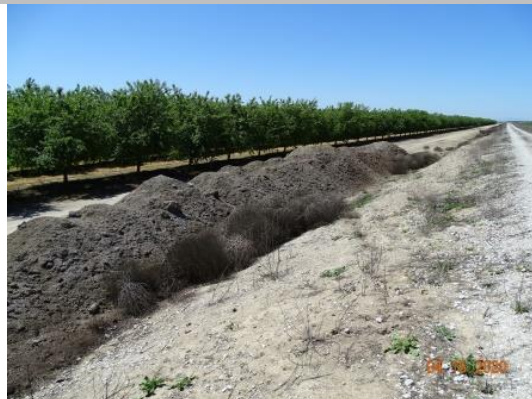
Photo 1 of 1 : SP_2020_NA0011_147_68_20200504_00060.jpg

LM Start	2.41	Rating **	U	Issue No.	68
LM End	2.43	Issue Type +	En	Location *	LS
Category	Earthen Levee			GPS Latitude/Longitude	
				Start	End
Item	Encroachments			36.967246 °	36.967250 °
				-120.329410 °	-120.329086 °
DWR ID	DWR_NA0011_06_s_2020_68				
Comment Code					
DE : Debris					
Inspector Comment

Soil material piled along the landside toe. (Spring 2020)

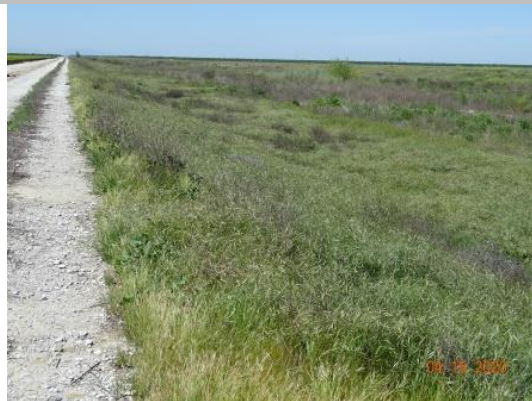
Photo 1 of 1 : SP_2020_NA0011_147_64_20200504_00061.jpg

LM Start	2.46	Rating **	U	Issue No.	64
LM End	3.47	Issue Type +	Ma	Location *	WS
Category	Earthen Levee			GPS Latitude/Longitude	
				Start	End
Item	Vegetation			36.967246 °	36.967380 °
				-120.328536 °	-120.310251 °
DWR ID	DWR_NA0011_06_s_2020_64				
Comment Code					
V1 : Control annual grass and weeds on the levee slopes and easements.					
Inspector Comment

Looking downstream along the waterside slope. (Spring 2020)

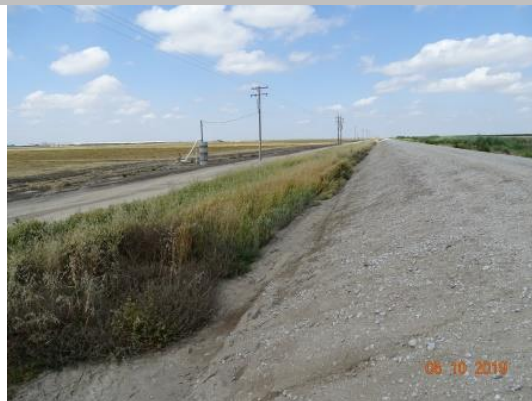
Photo 1 of 1 : SP_2020_NA0011_147_77_20200225_00034.jpg

LM Start	3.99	Rating **	U	Issue No.	77
LM End	5.48	Issue Type +	En	Location *	LS
Category	Earthen Levee			GPS Latitude/Longitude	
				Start	End
Item	Encroachments			36.967439 °	36.967487 °
				-120.300974 °	-120.273999 °
DWR ID	DWR_NA0011_06_s_2019_77				
Comment Code					
CR : Crops					
Inspector Comment					
Landowner has planted corn along the landside toe.

Crops planted on the landside toe. (Spring 2019)

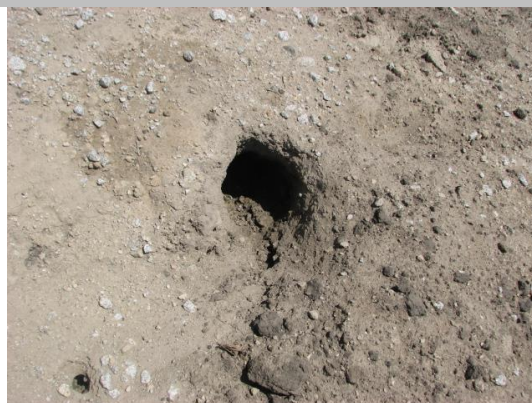
Photo 1 of 1 : SP_2020_NA0011_147_53_20200225_00027.jpg

LM Start	5.44	Rating **	M	Issue No.	53
LM End	5.44	Issue Type +	Ma	Location *	LS
Category	Earthen Levee			GPS Latitude/Longitude	
				Start	End
Item	Animal Control			36.967514 °	36.967514 °
				-120.274810 °	-120.274810 °
DWR ID	DWR_NA0011_06_s_2018_53				
Comment Code					
A3 : No rodents visible, but rodent burrows visible; need to backfill and compact or grout burrows.					
Inspector Comment					
Control rodents within this section.

Looking at typical rodent hole on landward slope. (Spring 2018)

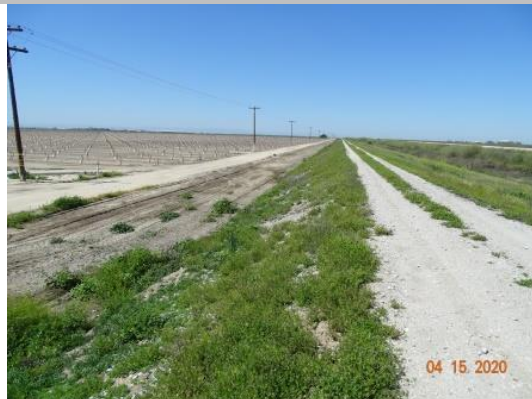
Photo 1 of 1 : SP_2020_NA0011_147_49_20200504_00064.jpg

LM Start	5.48	Rating **	M	Issue No.	49
LM End	5.96	Issue Type +	Ma	Location *	LS
Category	Earthen Levee			GPS Latitude/Longitude	
				Start	End
Item	Vegetation			36.967492 °	36.967480 °
				-120.273970 °	-120.265261 °
DWR ID	DWR_NA0011_06_s_2020_49				
Comment Code					
V1 : Control annual grass and weeds on the levee slopes and easements.					
Inspector Comment

View of the landside slope looking downstream. (Spring 2020)

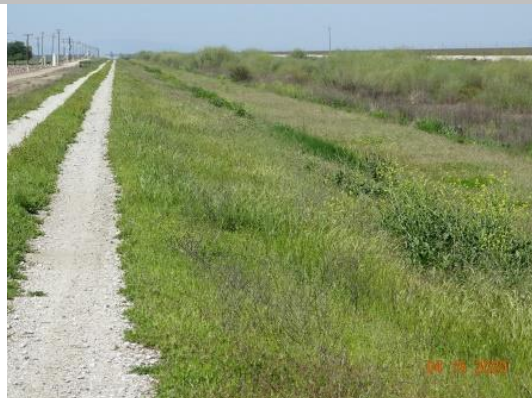
Photo 1 of 1 : SP_2020_NA0011_147_61_20200504_00063.jpg

LM Start	5.48	Rating **	M	Issue No.	61
LM End	5.96	Issue Type +	Ma	Location *	WS
Category	Earthen Levee			GPS Latitude/Longitude	
				Start	End
Item	Vegetation			36.967492 °	36.967480 °
				-120.273970 °	-120.265261 °
DWR ID	DWR_NA0011_06_s_2020_61				
Comment Code					
V1 : Control annual grass and weeds on the levee slopes and easements.					
Inspector Comment

View of waterside slope looking downstream. (Spring 2020)

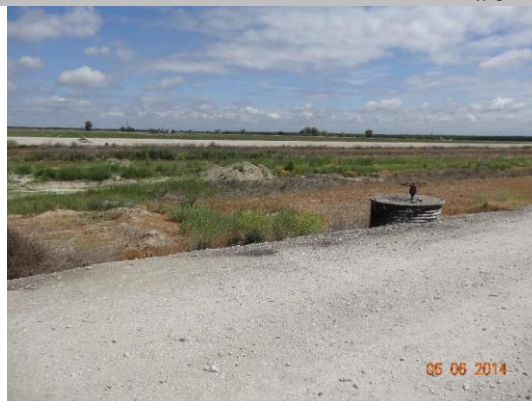
Photo 1 of 3 : UCIP_SP_2020_52854_64570.jpg

LM Start	6.17	Rating **	M	Issue No.	86
LM End	6.17	Issue Type +	En	Location *	
Category	Supplemental			GPS Latitude/Longitude	
				Start	End
Item	DWR UCIP Field Study			36.967568 °	36.967568 °
				-120.261594 °	-120.261594 °
DWR ID	21531				
Comment Code					
Inspector Comment					
DS_ID:21531 FS_ID:52854 EP_NO: N/A Repair Type: Non-Urgent Crossing Status: Found UCIP Comments: 05/06/2014 Need to contact owner. Recommend removing sediment built up on landward side. (DWR UCIP - O. Magana) FIELD_STRUCT_DESC: 48-inch corrugated metal gravity drainage pipe through the levee, 11.5 feet below the crown. Slide gate on the waterside (WS) shoulder. Headwall and wing wall on each end. Flap gate on the WS end. [Additional Reference(s): DWR Levee Log, 2005]. FS Date: 5/6/2014

View of waterward side.

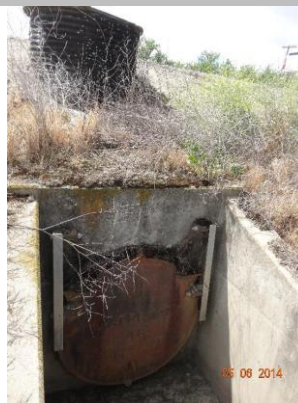
Photo 2 of 3 : UCIP_SP_2020_52854_64573.jpg

Flap gate, concrete headwall, and standpipe on waterward side.

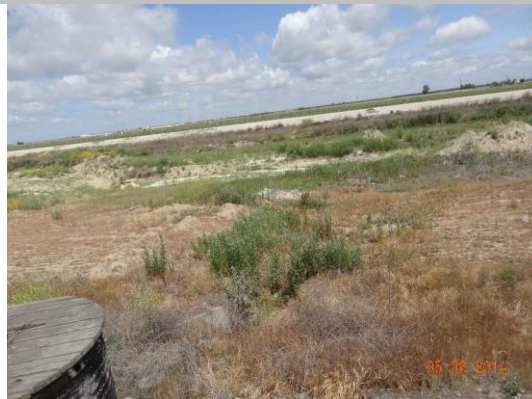
Photo 3 of 3 : UCIP_SP_2020_52854_64572.jpg

Overview of channel at crossing.

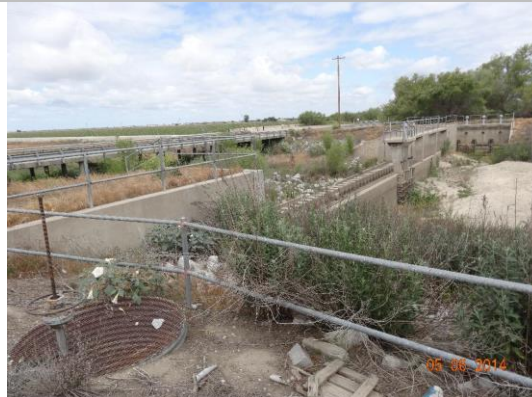
Photo 1 of 3 : UCIP_SP_2020_52855_69722.jpg

Comment Code						
Inspector Comment						
DS_ID:21532 FS_ID:52855 EP_NO: N/A Repair Type: Non-Urgent Crossing Status: Found UCIP Comments: 7/14/2016 Same as previous inspection. Need to coordinate with owner. Need permit number authorizing work. (DWR UCIP - omagana)5/06/2014 Need to contact owner. Crossing on landward side appears to be modified--no headwall found on landward end. (DWR UCIP - omagana) FIELD_STRUCT_DESC: 30-inch corrugated metal pipe (CMP) of an unknown purpose through the levee, 12 feet below the crown. Slide gate in a 5-foot CMP riser on the waterside (WS) shoulder. Headwall and wing wall on the WS end. Concrete headwall on the landside (LS) end. [Additional Reference(s): DWR Levee Log, 2005]. FS Date: 7/14/2016

View of WS.

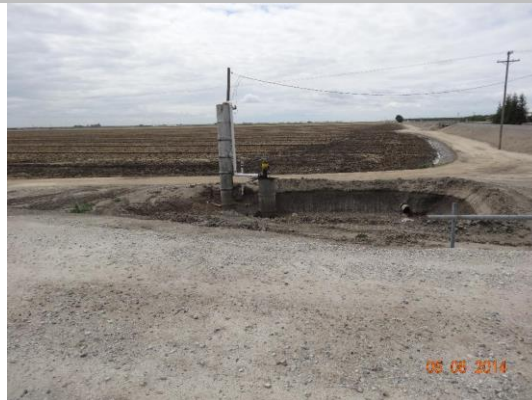
Photo 2 of 3 : UCIP_SP_2020_52855_69724.jpg

View of LS.

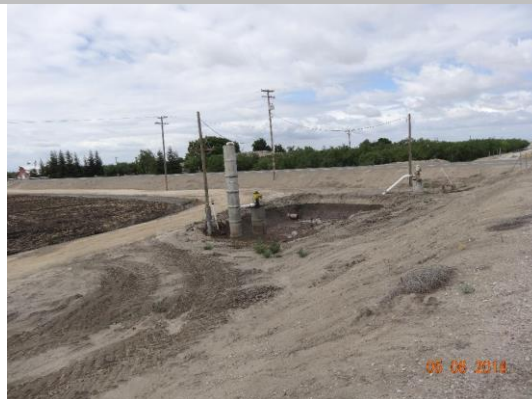
Photo 3 of 3 : UCIP_SP_2020_52855_69723.jpg

Additional structures found on LS.

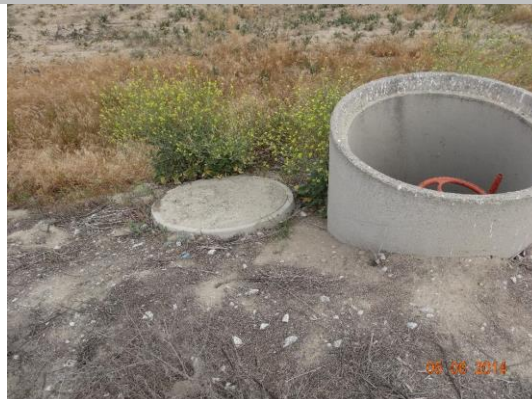
Photo 2 of 3 : UCIP_SP_2020_52860_64588.jpg

View of concrete standpipe and lid found on waterward shoulder.

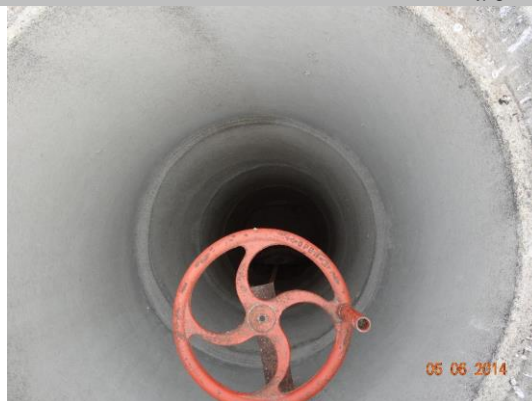
Photo 3 of 3 : UCIP_SP_2020_52860_64584.jpg

Inside view of standpipe located on waterward side.

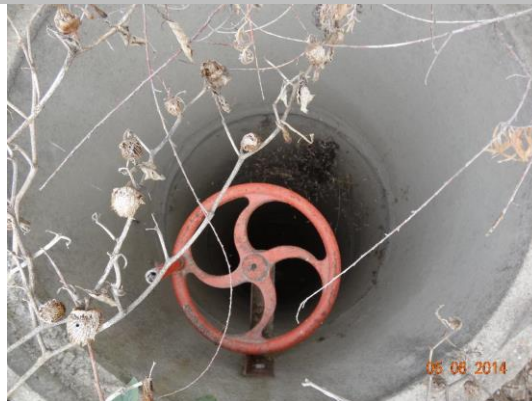
Photo 2 of 3 : UCIP_SP_2020_52861_64589.jpg

Inside view of standpipe located on waterward side.

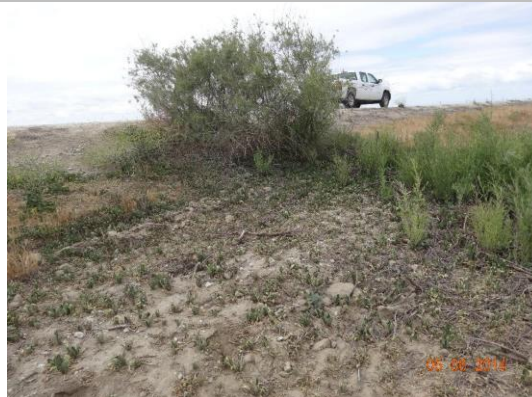
Photo 3 of 3 : UCIP_SP_2020_52861_64594.jpg

View of waterward slope.

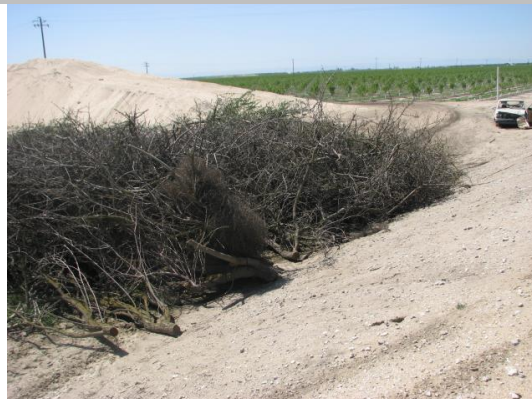
Photo 1 of 1 : SP_2020_NA0011_147_52_20200225_00025.jpg

LM Start	7.49	Rating **	U	Issue No.	52
LM End	7.49	Issue Type +	En	Location *	LS
Category	Earthen Levee			GPS Latitude/Longitude	
				Start	End
Item	Encroachments			36.968886 °	36.968886 °
				-120.237967 °	-120.237967 °
DWR ID	DWR_NA0011_06_s_2018_52				
Comment Code					
PR : Prunings					
Inspector Comment					
Farmer is piling large tree limbs and branches at landward toe.

Looking upstream at prunings at landward toe. (Spring 2018)

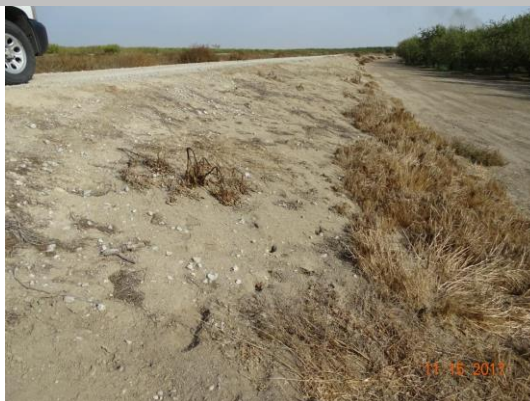
Photo 1 of 1 : SP_2020_NA0011_147_47_20200225_00021.jpg

LM Start	7.71	Rating **	M	Issue No.	47
LM End	8.18	Issue Type +	Ma	Location *	LS
Category	Earthen Levee			GPS Latitude/Longitude	
				Start	End
Item	Animal Control			36.969600 °	36.971842 °
				-120.234229 °	-120.226393 °
DWR ID	DWR_NA0011_06_f_2017_47				
Comment Code					
A3 : No rodents visible, but rodent burrows visible; need to backfill and compact or grout burrows.					
Inspector Comment

Bait traps should be maintained and rodent holes should be backfilled.

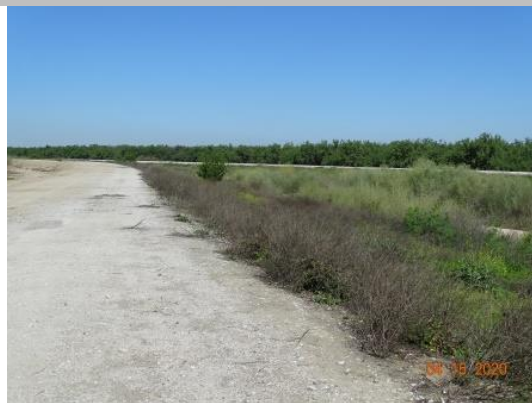
Photo 1 of 1 : SP_2020_NA0011_147_25_20200504_00066.jpg

LM Start	7.95	Rating **	U	Issue No.	25
LM End	8.51	Issue Type +	Ma	Location *	WS
Category	Earthen Levee			GPS Latitude/Longitude	
				Start	End
Item	Vegetation			36.971485 °	36.971546 °
				-120.230566 °	-120.220596 °
DWR ID	DWR_NA0011_06_s_2020_25				
Comment Code					
V1 : Control annual grass and weeds on the levee slopes and easements.					
Inspector Comment

View of the waterside slope looking downstream. (Spring 2020)

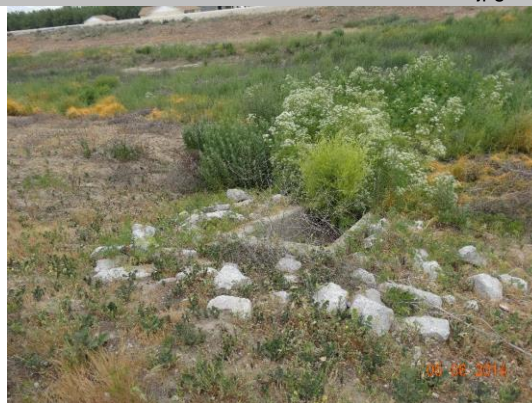
Photo 2 of 3 : UCIP_SP_2020_52864_64599.jpg

Rip rap around concrete headwall located on waterward side.

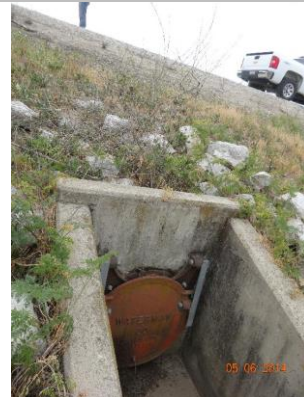
Photo 3 of 3 : UCIP_SP_2020_52864_64598.jpg

Flap gate visible on waterward side.

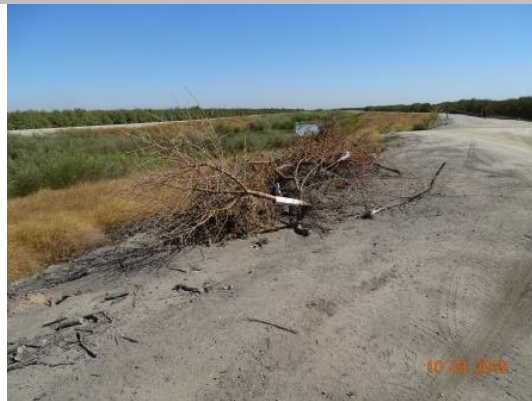
Photo 1 of 1 : SP_2020_NA0011_147_11_20200225_00003.jpg

LM Start	8.57	Rating **	M	Issue No.	11
LM End	8.57	Issue Type +	En	Location *	CR
Category	Earthen Levee			GPS Latitude/Longitude	
				Start	End
Item	Encroachments			36.971347 °	36.971347 °
				-120.219640 °	-120.219640 °
DWR ID	DWR_NA0011_06_f_2019_11				
Comment Code					
PR : Prunings					
Inspector Comment

Pruning pile left on waterside shoulder and levee crown. (Fall 2019)

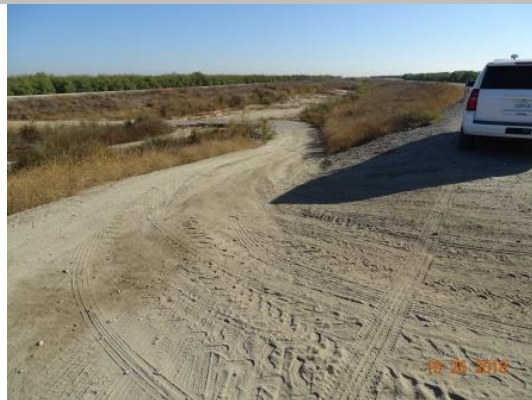
Photo 1 of 1 : SP_2020_NA0011_147_55_20200225_00029.jpg

LM Start	8.59	Rating **	M	Issue No.	55
LM End	8.59	Issue Type +	En	Location *	WS
Category	Earthen Levee			GPS Latitude/Longitude	
				Start	End
Item	Encroachments			36.971314 °	36.971314 °
				-120.219339 °	-120.219339 °
DWR ID	DWR_NA0011_06_f _ 2018_55				
Comment Code					
RA : Ramp					
Inspector Comment

Unpermitted ramp on waterside slope. (Fall 2018)

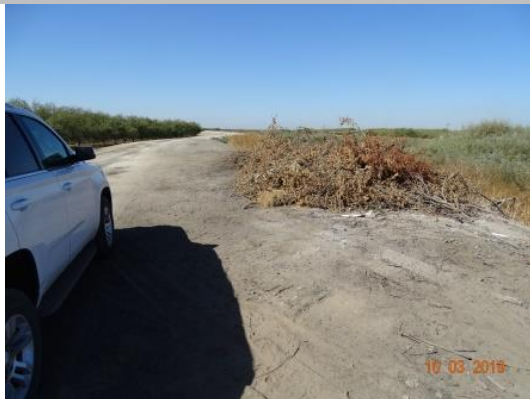
Photo 1 of 1 : SP_2020_NA0011_147_50_20200225_00022.jpg

LM Start	8.93	Rating **	U	Issue No.	50
LM End	8.93	Issue Type +	En	Location *	CR
Category	Earthen Levee			GPS Latitude/Longitude	
				Start	End
Item	Encroachments			36.972286 °	36.972286 °
				-120.213284 °	-120.213284 °
DWR ID	DWR_NA0011_06_f _ 2017_50				
Comment Code					
PR : Prunings					
Inspector Comment					
Remove or burn pruning pile on crown.

Pruning pile left on waterside shoulder and crown. (Fall 2019)

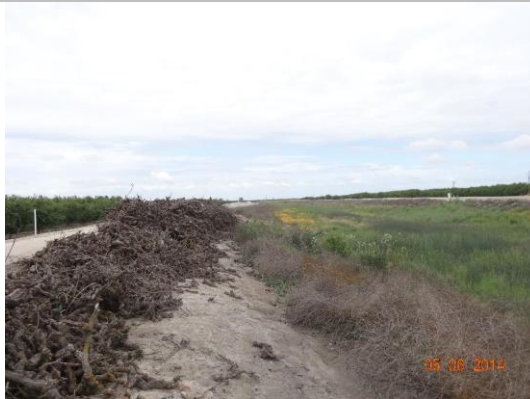
Photo 1 of 3 : UCIP_SP_2020_53156_64605.jpg

Comment Code						
Inspector Comment						
DS_ID:21530 FS_ID:53156 EP_NO: N/A Repair Type: Urgent Crossing Status: Found UCIP Comments: 10/31/2018 Same as last inspection. Surface erosion present due to highly erodible soil. Deep hole behind concrete headwall presently unable to confirm if hole is associated with burrow activity or sink hole. Recommend internal inspection to determine pipe integrity through the levee. Crossing remains Urgent due to the unknown condition of the pipe integrity through the levee. (O. Magana - DWR UCIP) 07/14/2016 Surface erosion still present on LS shoulder. Unable to determine if surface erosion is due to internal pipe failure. Unable to locate concrete headwall on WS toe. Need to coordinate with owner to address erosion or potential pipe failure. Also recommend removing dense vegetation on WS. (DWR UCIP - omagana) 05/06/2014 Need to contact owner. Surface erosion on landward slope unable to determine if pipe failed or if rodent activity burrow hole has caused collapse on slope. Need to determine cause for erosion. (DWR UCIP - omagana) FIELD_STRUCT_DESC: 30-inch corrugated metal gravity drainage pipe through the levee, 10.2 feet below the crown. Headwall and wing wall on each end. Flap gate on the waterside (WS) end. [Additional Reference(s): DWR Levee Log, 2005]. FS Date: 10/31/2018 10:21:00 AM

View of WS.
